ASTM E1592 TEST RESULTS SS1500 PANEL

Engineering Report 96505-4

Zimmerman Metals, Inc., SS1500 Standing Seam Panel Uplift Test

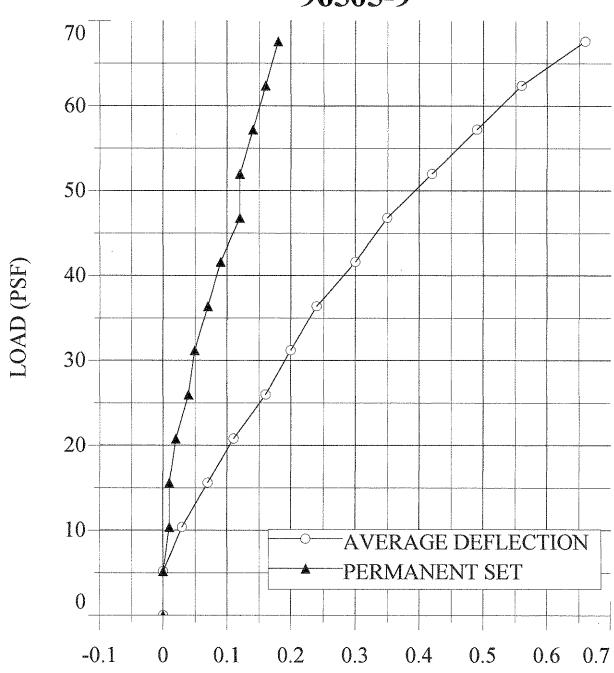
RIB MIDSPAN

PANEL TEST 96505-9

The deflection of the panels during testing is represented graphically in the pages that follow:

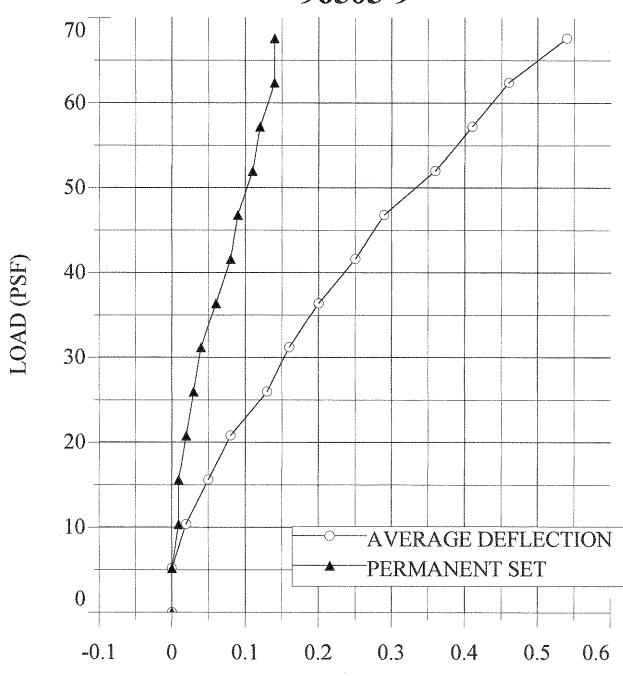
RIB SUPPORT

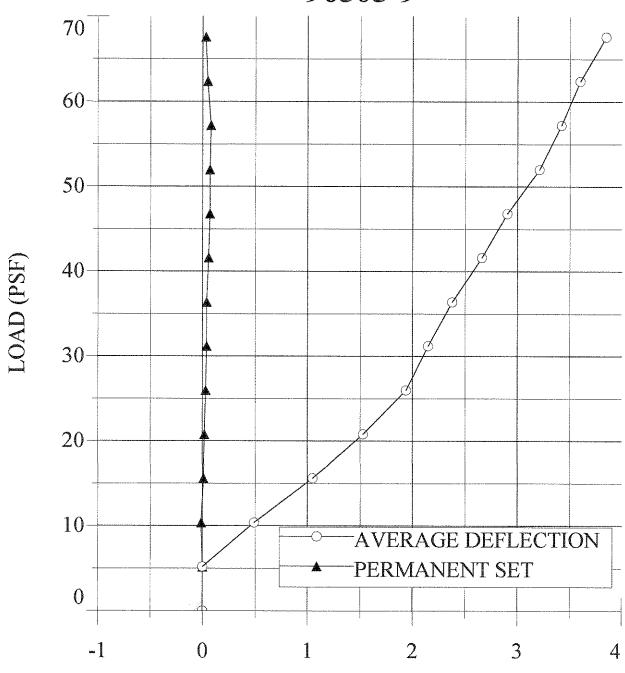
DEFLECTION (INCHES)

MID PANEL MIDSPAN

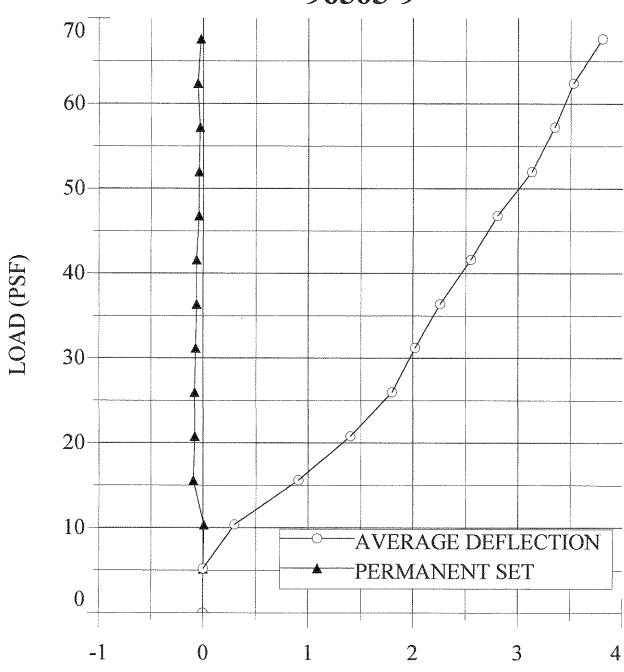
MID PANEL SUPPORT

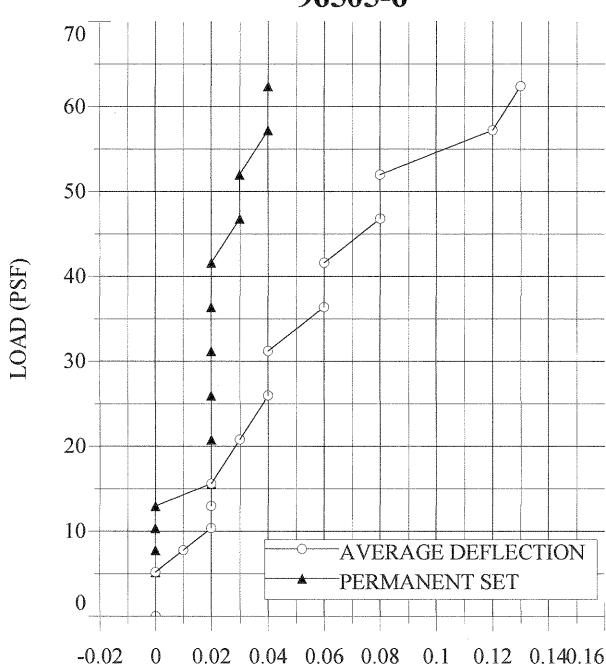
RIB MIDSPAN

PANEL TEST 96505-6

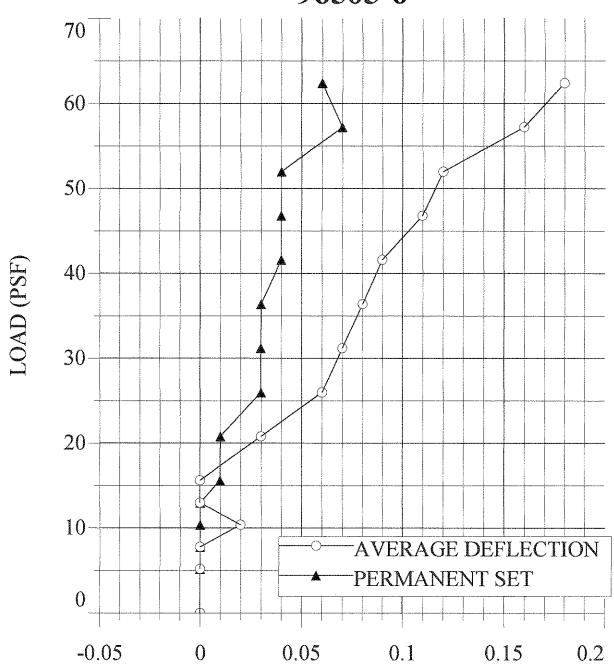
DEFLECTION (INCHES)

RIB SUPPORT

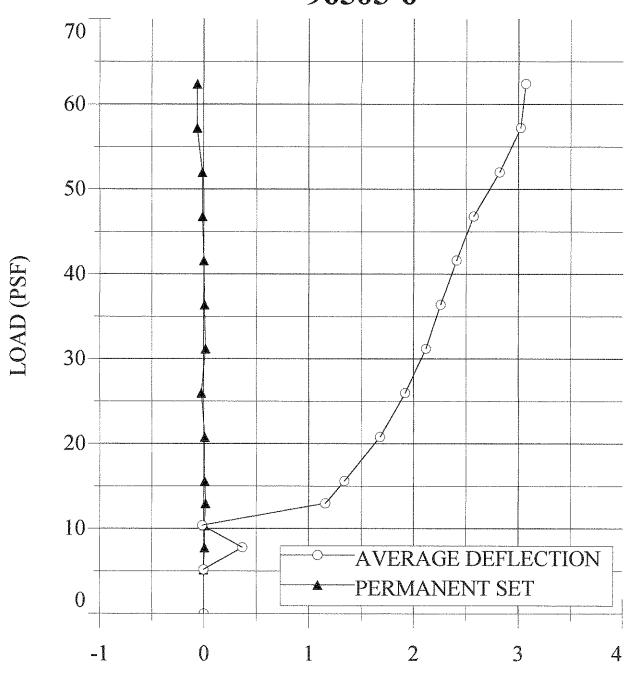
MID PANEL MIDSPAN

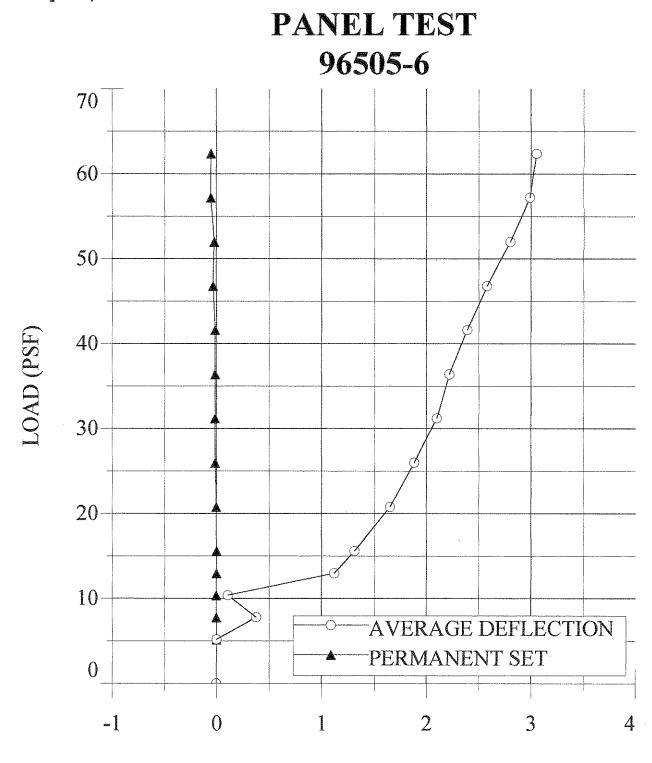
MID PANEL SUPPORT

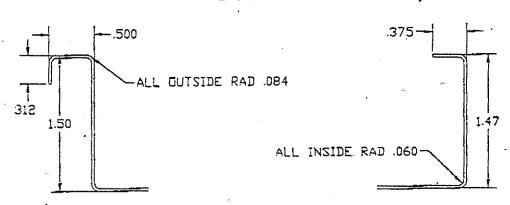
SS1500

1 1/2" STANDING SEAM

The SS1500 Standing Seam panels covered a nominal 16 inches and had 1 1/2-inch ribs (Figure 1). The material used to form the panels was 24 gage, 56.1 KSI average yield strength for 3-foot, 6-inch suport and 62.6 KSI for 1 foot 0-inch support test (determined by Cerny & Ivey, see attached Laboratory

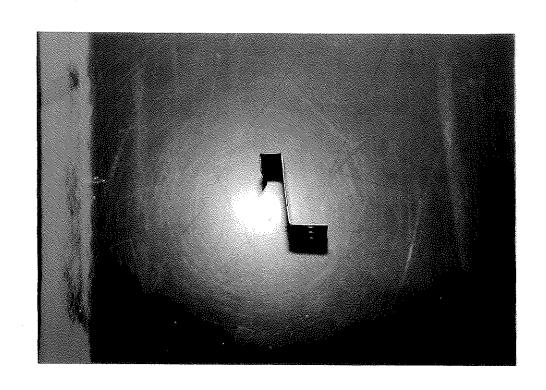
PHOTOGRAPH A STANDING SEAM CLIP

Clips supplied by Architectural Metal Specialties (1 1/2 inch 24 ga. steel Standing Seam clips) were used to attach the panels to the formed cee and zee sections (Photographs A through D). Each clip was attached to the support with two 1 inch by No. 8 self drill and tap pancake head screws (Photograh E). The starting edge of the first panel was secured with a 24 gage J-track. The J-track was attached to supports at 1 foot on centers. A formed edge detail lapped over the J-track and panel leg (Photograph F through N). The 24 gage edge detail was attached to the J-track with 1 inch by No. 8 self drill and tap pancake head screws spaced 1 foot on centers.

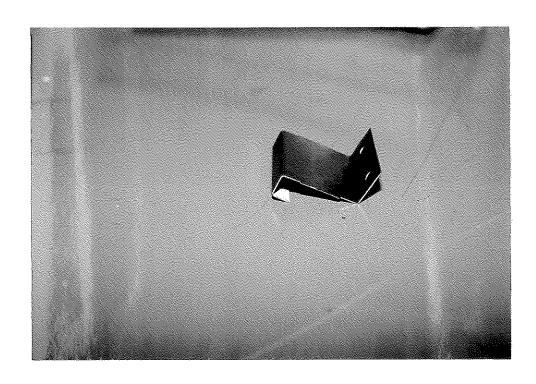
PHOTOGRAPH B STANDING SEAM CLIP

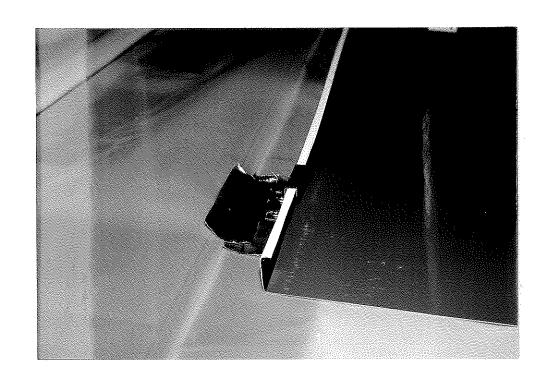
PHOTOGRAPH C INSTALLATION OF CLIP

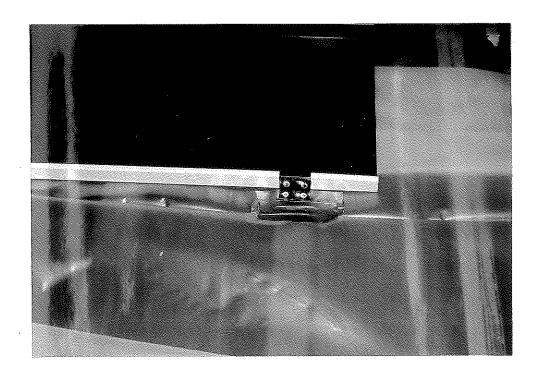
<u>PHOTOGRAPH D</u> CLIP INSTALLATION

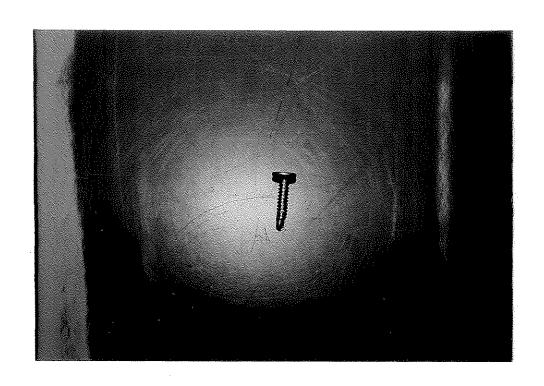
PHOTOGRAPH E
TYPICAL PANCAKE HEAD FASTENER

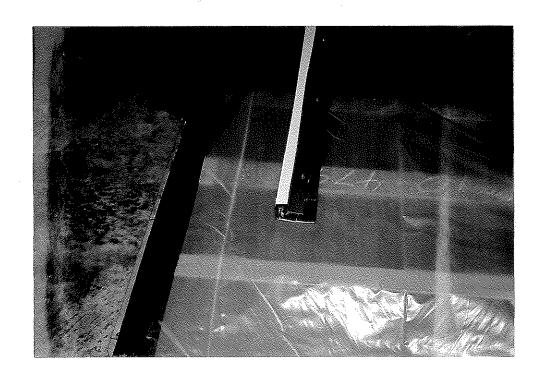
J-TRACK INSTALLED ON SUPPORTS

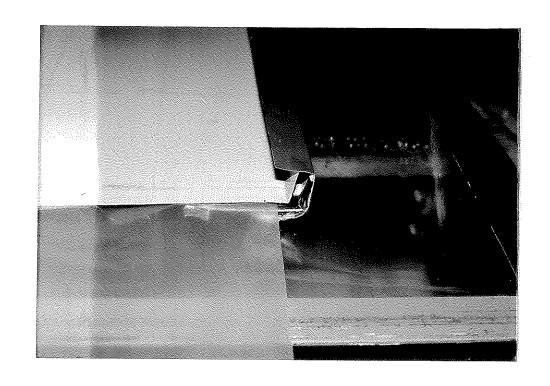
PHOTOGRAPH G J-TRACK AND PANEL

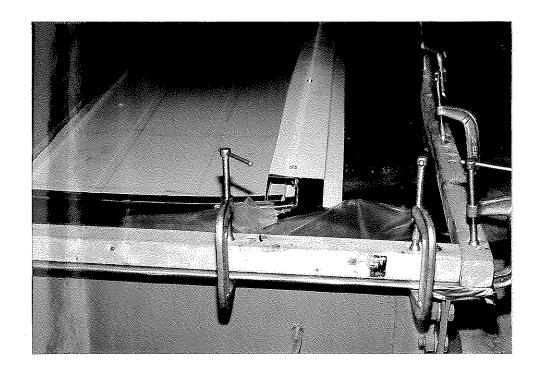
PHOTOGRAPH H EDGE DETAIL

During installation each panel was lapped over the preceding panel and locked into place by hand crimping one end. A panel was split to finish the leading edge. No additional fasteners were installed on the leading edge.

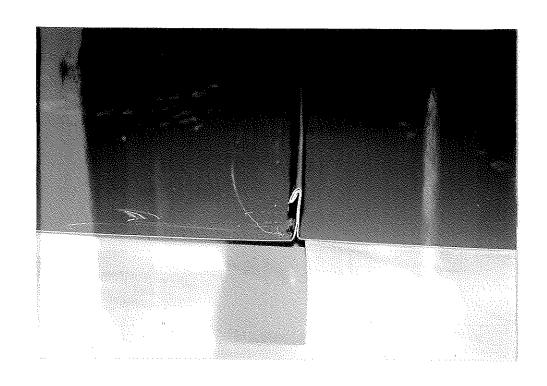
PHOTOGRAPH I
PROFILE OF CRIMPED PANEL SEAM

After installation, the panel seams were double crimped with an electric seamer supplied by AMSI (Photograph I). The final specimen size was 21 feet, 0 inches long (11 feet, 0 inches for 1 foot on centers) by 6 feet, 8 inches (five panels) wide (Photographs J and K).

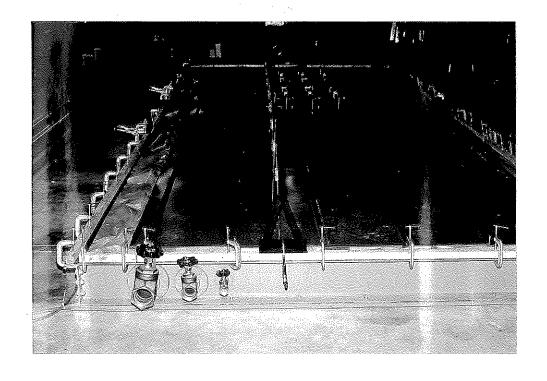
ASSEMBLED PANEL WITH 3-FOOT, 6-INCH SUPPORTS

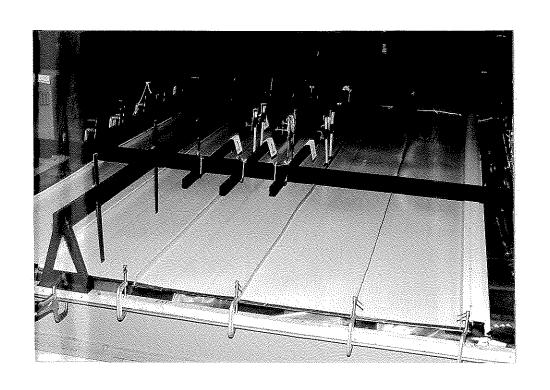
PHOTOGRAPH K
ASSEMBLED PANEL WITH 1 FOOT 0 INCH SUPPORTS

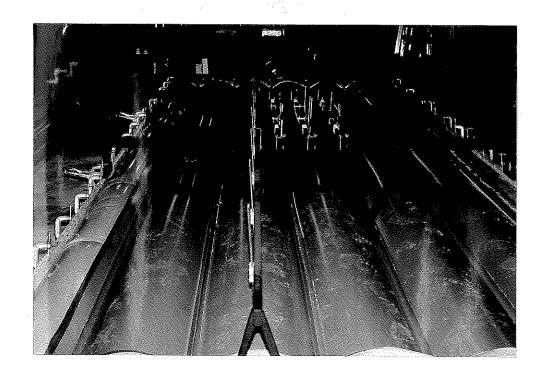
PHOTOGRAPH L
TEST PANEL 96505-9 WITH LOAD APPLIED

Test No. 96505-9 (Photographs L through N)
Specimen: Zimmerman Metals Standing Seam Panel, 24 gage,
56.1 KSI Painted galvanized steel, 3 1/2 foot

10.4 PSF	Visible deflection of pans
5.2 PSF	Panels return to initial shape
15.6 PSF	Increased pan deflection,
	visible spreading of panel ribs
5.2 PSF	Panels return to initial shape
41.6 PSF	Increased pan deflection and rib spread
5.2 PSF	Set in leading edge pan
52.0 PSF	Increased pan deflection and rib spread.
	Ribs rotate in clips
5.2 PSF	Set at pan ends
57.2 PSF	Deformation at clip locations
72.8 PSF	Panel ribs unseam at clips

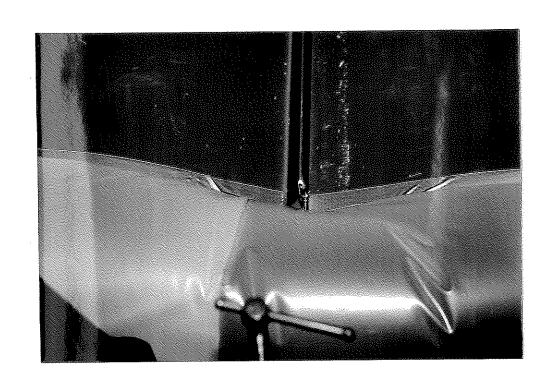
PHOTOGRAPH M
SPREADING OF PANEL RIB

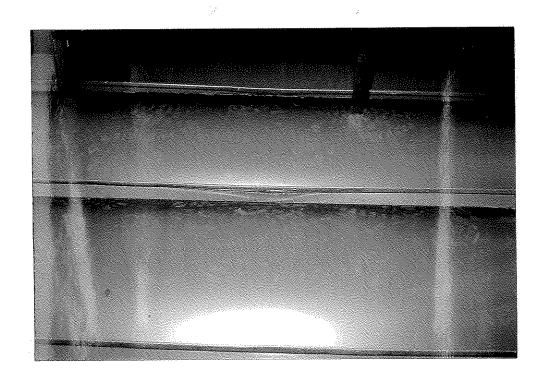
PHOTOGRAPH N FAILURE OF SEAM AT CLIP

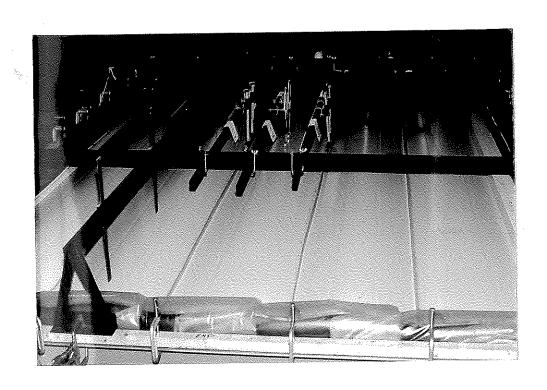
PHOTOGRAPH O
TEST PANEL 96505-6 WITH LOAD APPLIED

Test No. 96505-6 (Photographs O through Q)
Specimen: Zimmerman Metals Standing Seam Panel, 24 gage,
62.6 KSI Painted galvanized steel, 1 foot

- 52.0 PSF Increased pan deflection and rib spread 5.2 PSF Pan 5 does not return to flat 57.2 PSF Increased pan deflection and rib spread
- 5.2 PSF Pan 2 and 5 don't return to flat
- 127.9 PSF Maximum pressure available due to leakage

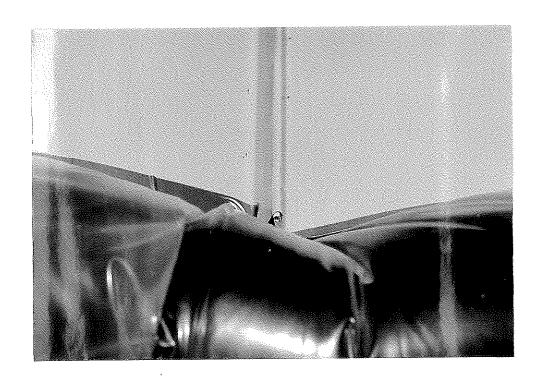
PHOTOGRAPH P SPREADING OF PANEL RIB

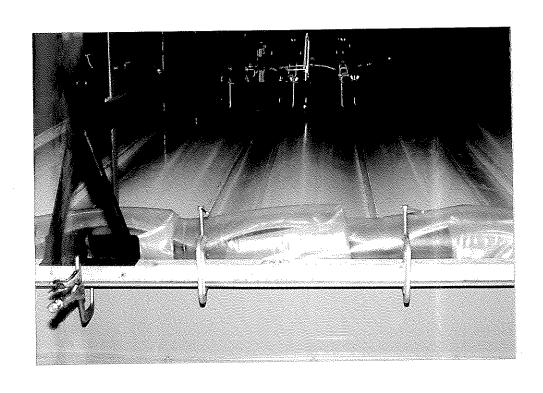
PHOTOGRAPH O
DEFLECTION OF PANEL WITH INCREASED LOAD
